# Seismic Crack Investigation in an Earth Dam by Centrifugal Loading Test

Akira Kobayashi and Akira Murakami

## Abstract

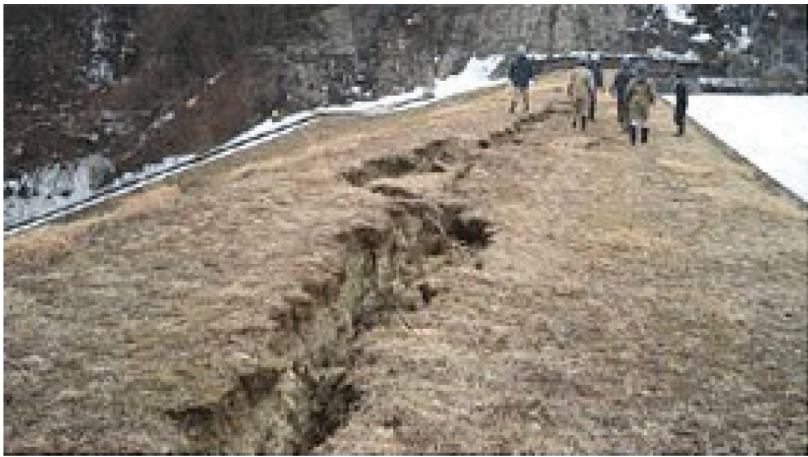
Figure 1. Crack at the Earth-fill dam.

Many irrigation dams were not designed for earthquake resistance, and the cracks at the crest in the direction of the dam axis are remarkable. **Figure 1** shows the example of the crack at the crest of the Earth-fill dam. The relatively big open crack occurred. This type of open crack can be seen in the damaged Earth-fill dam so often. Not only the old Earth-fill dam but also the recent rock-fill dam has a crack in the dam-axis direction when the big earthquake hit. **Figure 2** shows the crack situation at the crest of the rock-fill dam constructed in 1988. This dam was designed for earthquake resistance. Although the acceleration was not measured, it was inferred that relatively big acceleration occurred because the earthquake inducing the crack was in 2011 off the Pacific coast of Tohoku. The open crack was propagated at a 3 m depth from the crest. The cracks shown in the figures cannot be seen to be induced by shear failure. The earthquake resistance is examined for shear failure with the slip-circle method according to the standard. It is difficult to

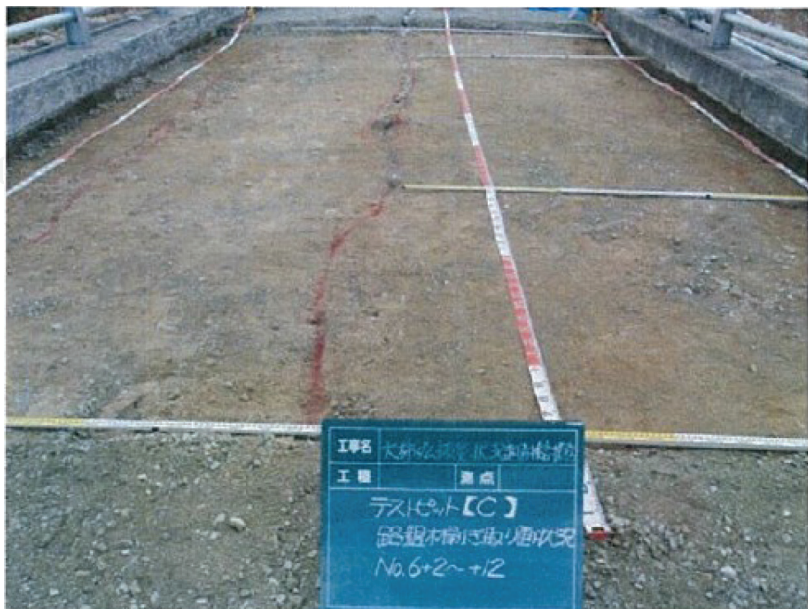
Figure 2. Crack at the rock-fill dam.

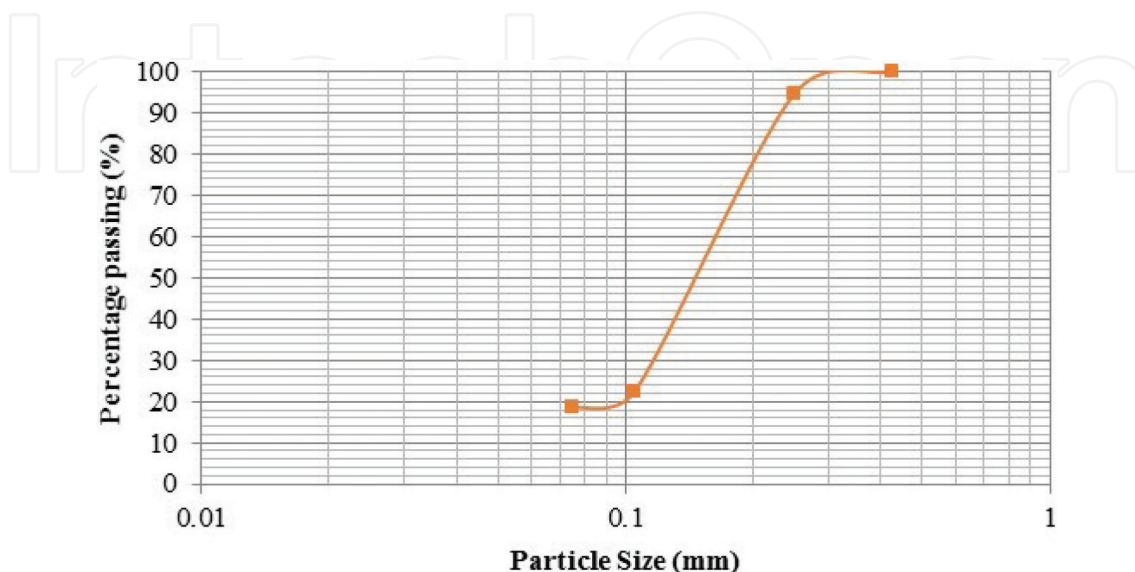
**Figure 5.** Particle size distribution used for the embankment model.

No. 7 silica sand and kaolin clay with the mixture ratio of 8:2 by dry weight. **Figure 5** shows the particle distribution of the mixture. The water content of the mixture was 13%. In order to evaluate the seismic behavior of the model, the gauge points were placed on the surface of the embankment model and the reference points were set at the foundation. The total number of the points is 82. To reduce the friction between embankment model and wall of the soil box, the silicone grease was painted on the wall surface. The accelerometers were installed on the foundation. The foundation was made of rigid material. By assuming that the distance of the reference points on the rigid foundation is not changed, the coordinate of the gauge points is calibrated.
